**Town of Jaffrey, NH
Town Offices Comparative Site Study**

**Weller & Michal Architects Inc.
July 30, 2010**

re: Jaffrey Phase I Property Assessments

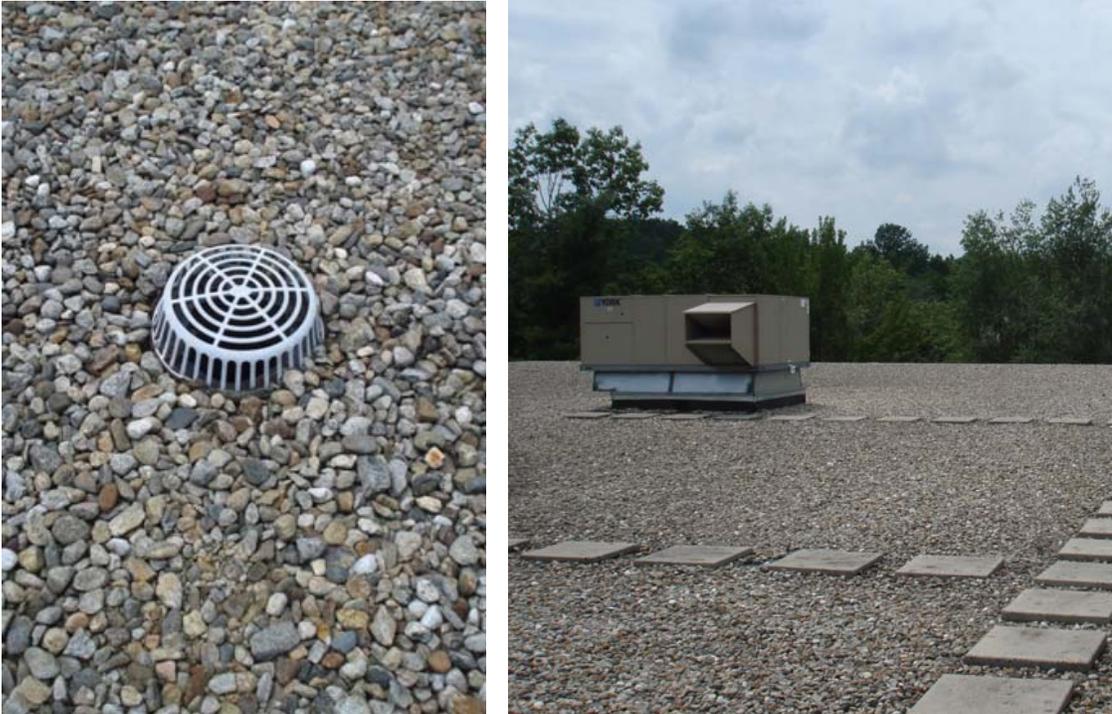
Figure 7 - Ballasted Stone EPDM Roof

Roofs are in good condition but are likely near the end of their useful life.

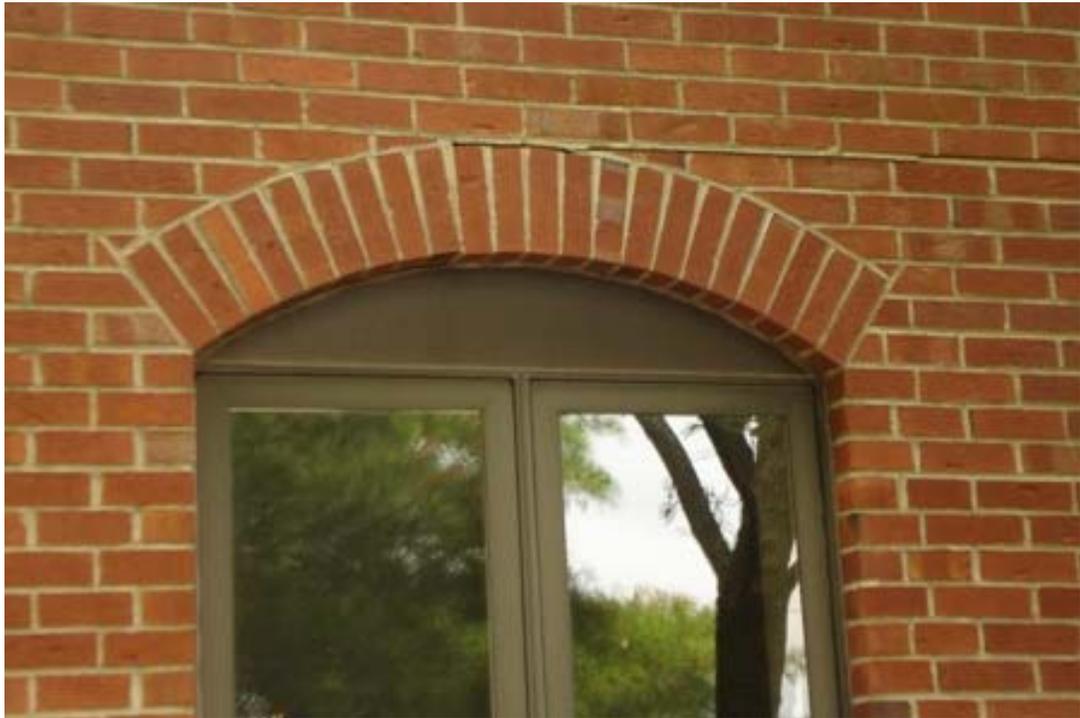
Walls are in good condition. Two small defects were noted. A brick arched window head at the north wall shows unrepaired settlement cracks. The lower level north foundation wall shows a previously repaired settlement crack.

Figure 8 - Settlement Damage to Arched Window Head

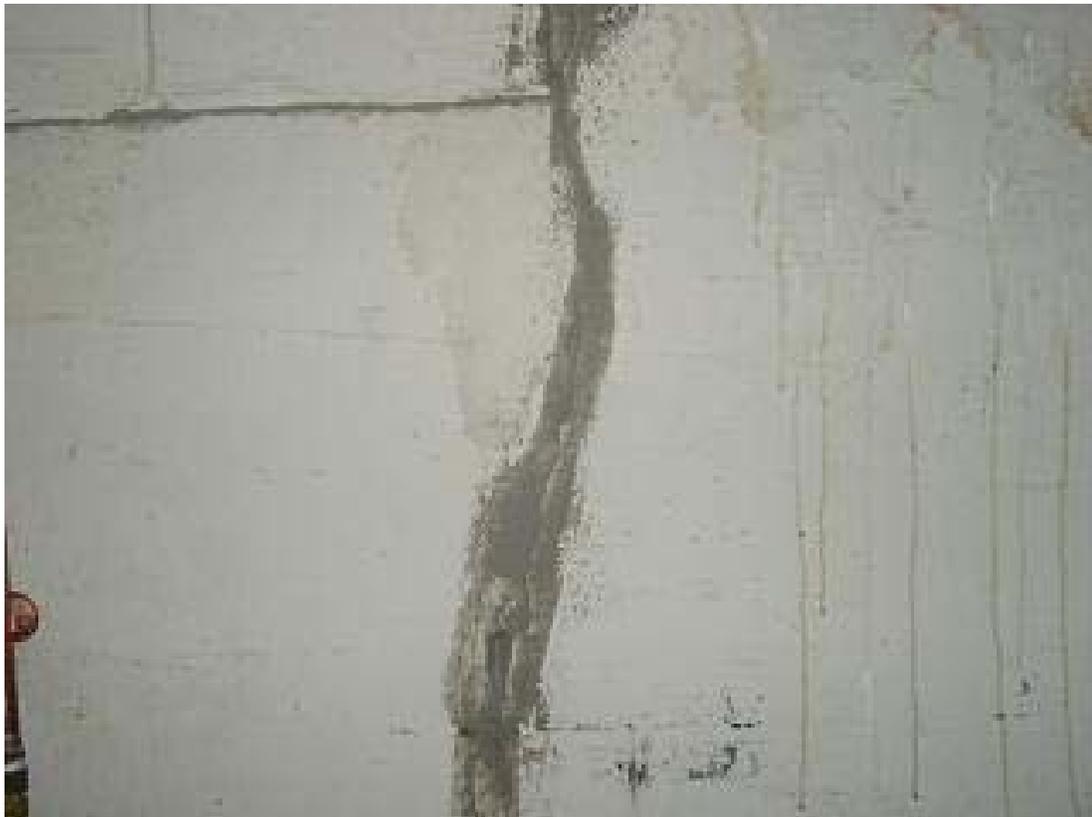
Figure 9 - North Foundation Wall Crack

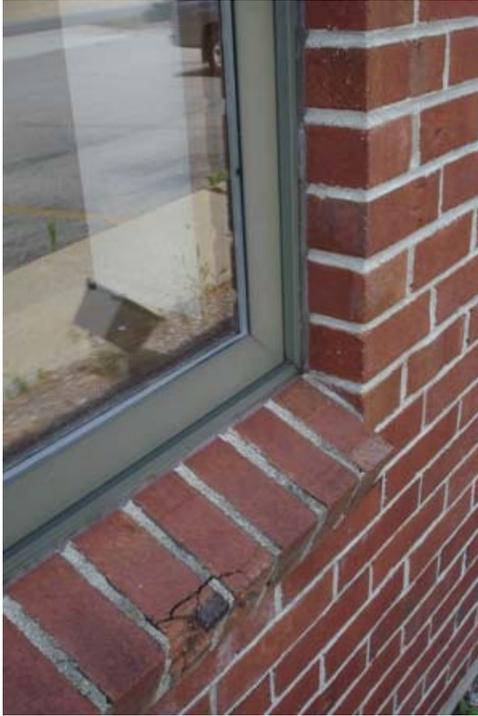
Figure 12 – Frost Damaged Rowlock Brick Sills

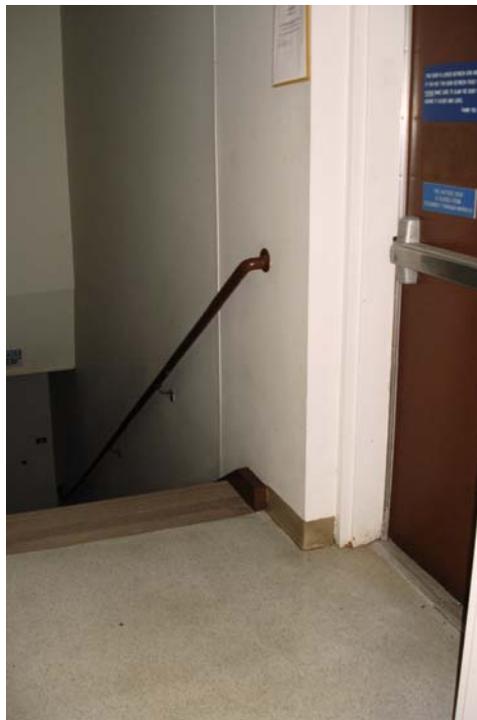
Figure 17 - Exit Door Conflict with Stair Landing

Two interior stairwells communicate and provide a second means of emergency egress from the lower level. These stairs have adequate width, rise and run but may need better enclosure at the top level to meet current fire codes.

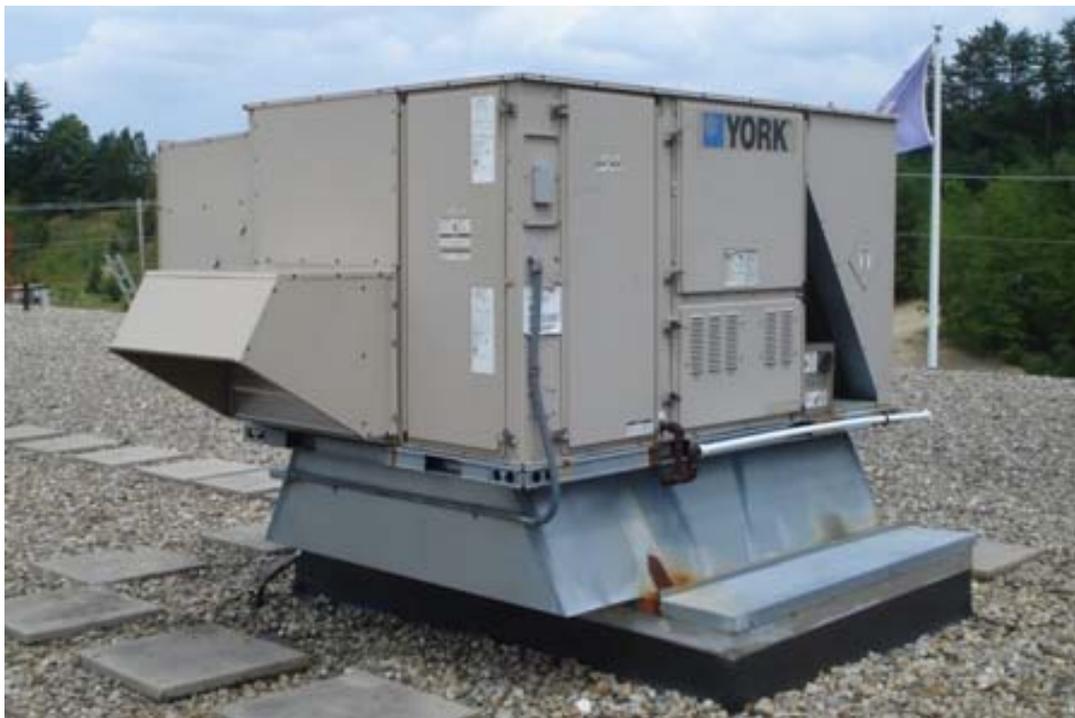
The building is served by older propane gas heat, DX cooling roof top units (RTUs). Two units, a 10-ton and a 15-ton serve the office space at the upper level and two 10-ton units serve the industrial space in the lower level.

Figure 18 - HVAC Roof Top Units

Because the rooftop units serving the office level are old and use a phase-out, environmental unfriendly refrigerant, and because zoning and ductwork changes would be needed to accommodate necessary plan changes for Town Offices, we recommend a complete replacement of the HVAC systems. The two RTUs serving the lower level can remain until a programmatic use for this extra floor area is established.

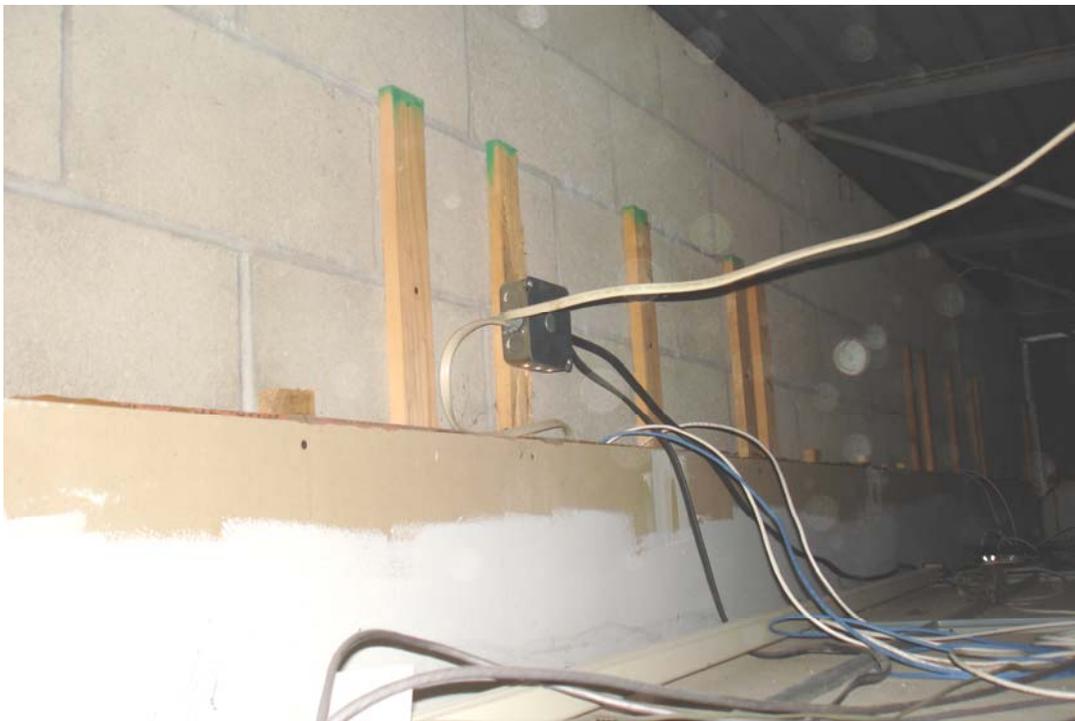
Distribution panels are original equipment or date from numerous tenant modifications. They are considered to be in poor condition and should be replaced.

Figure 22 - Electrical Distribution Shows Non-Code Tenant Modifications

The existing electrical distribution system shows extensive tenant modification that is not code compliant and should be replaced. New distribution to new lighting and power panels located as needed for the new uses is recommended. This need only be done for the upper level as the lower level should be redesigned around specific uses yet to be identified.

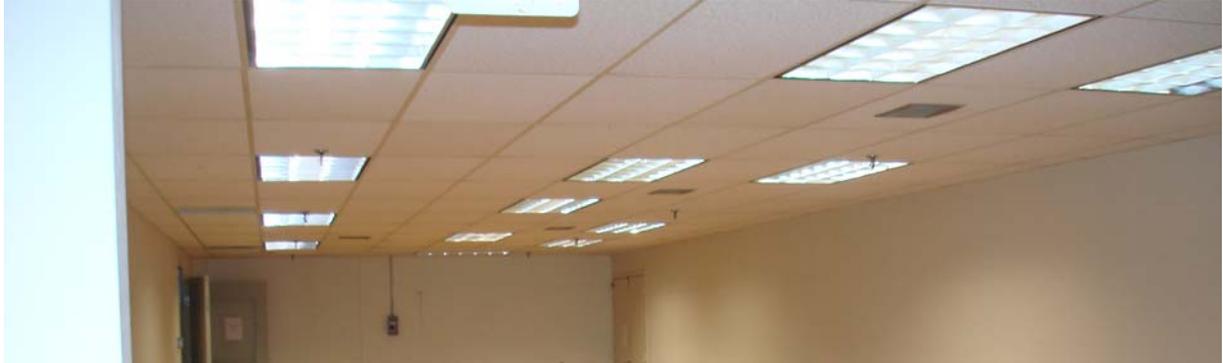
Figure 23 - Parabolic Troffer Lighting

Lighting in offices are older fixtures with three T8 lamps, originally provided with inboard and outboard switching. Ballasts show signs of failure. Installed wattage and fixtures are non energy efficient by current standards and should be replaced during necessary floor plan modifications.

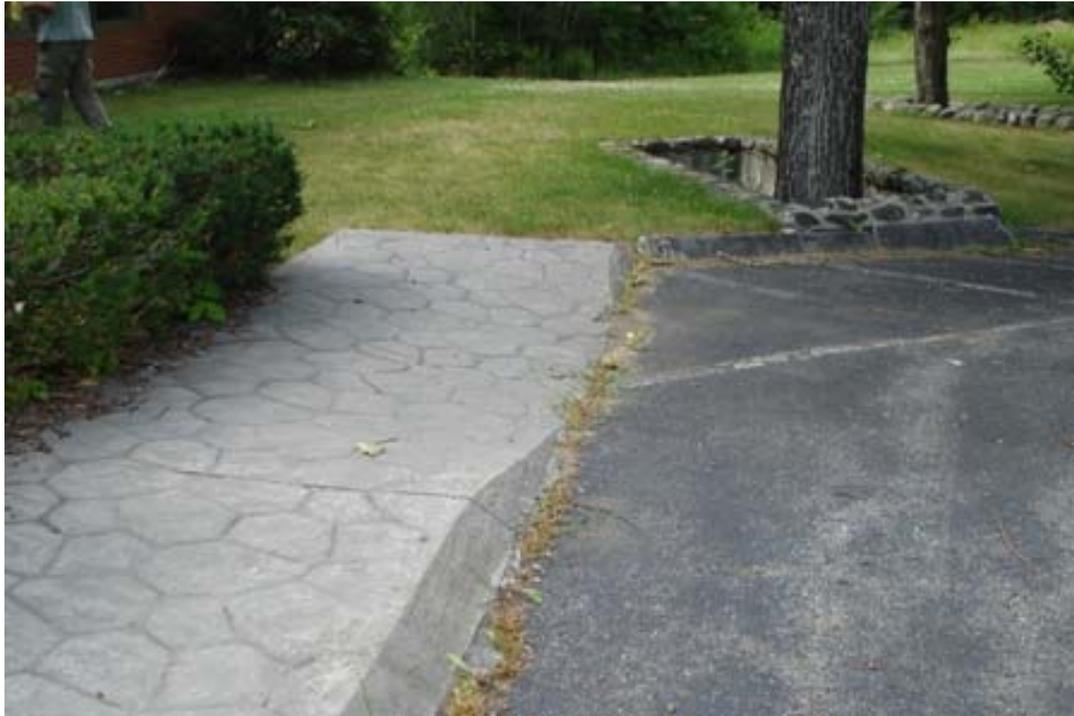
Figure 26 – Accessible Parking Needs Upgrades

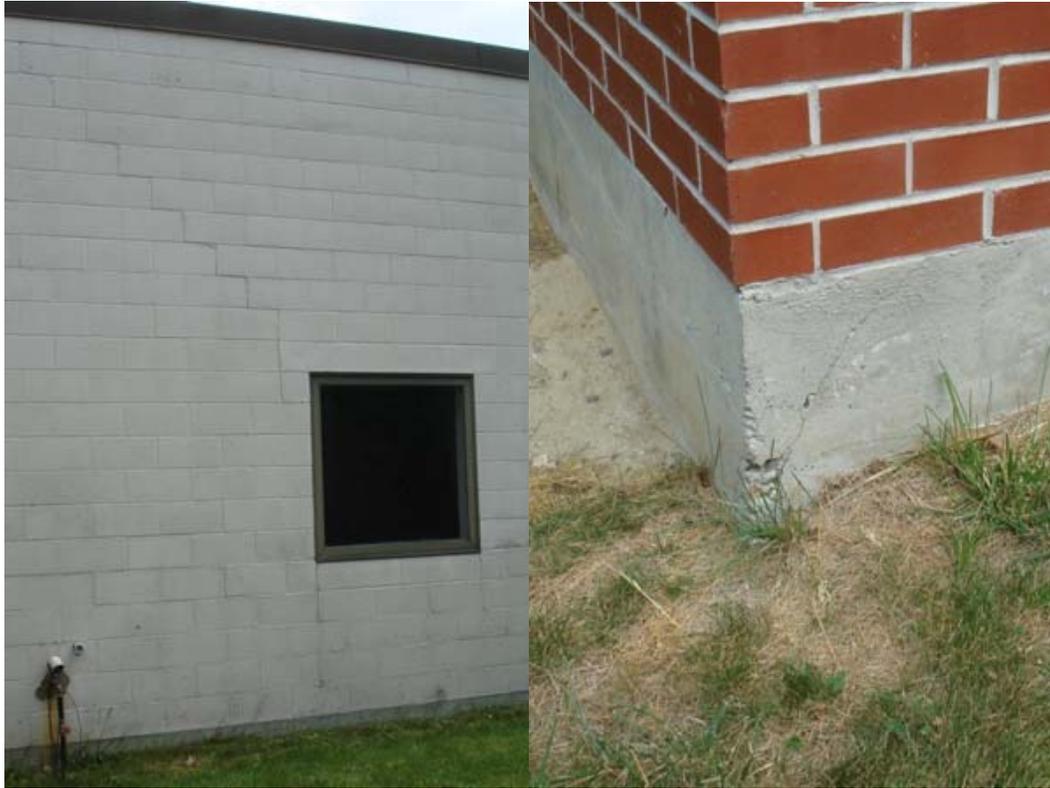
Figure 29 - CMU Cracks Need Repair

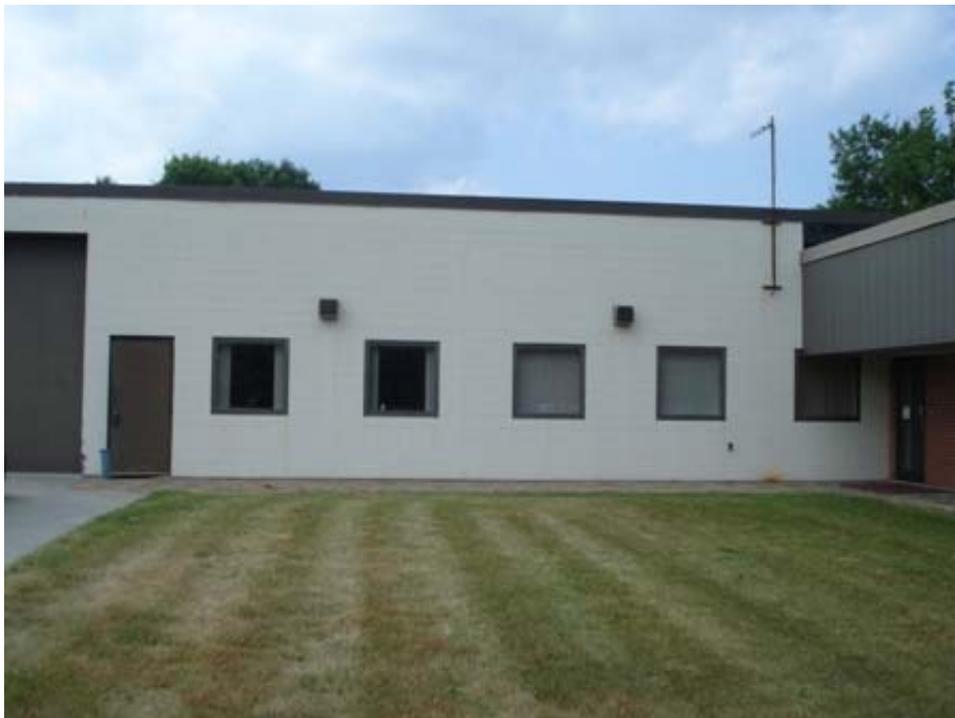
Figure 35 - Warehouse Windows Need Replacement

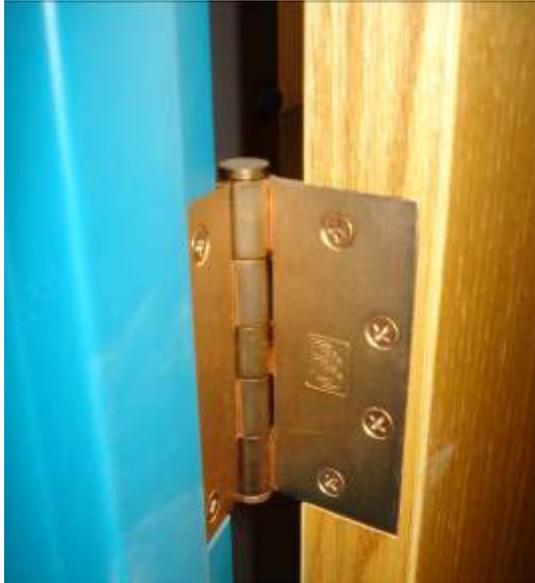
Doors are commercial solid core in knock-down HM (hollow metal) frames. Door hardware predates most accessibility codes and should be replaced.

Figure 41 - Door Hardware

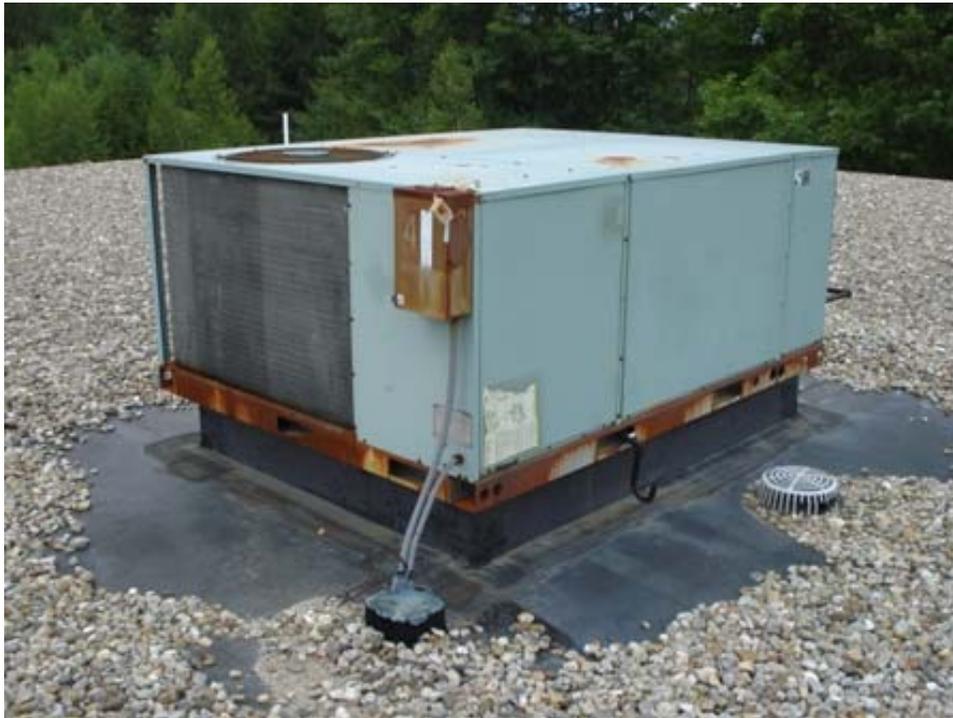
Figure 42 - Possibly Original Roof Top Units

Because the rooftop units are old and use a phase-out, environmental unfriendly refrigerant, and because zoning and ductwork changes would be needed to accommodate necessary plan changes for Town Offices, we recommend a complete replacement of the older rooftop units.

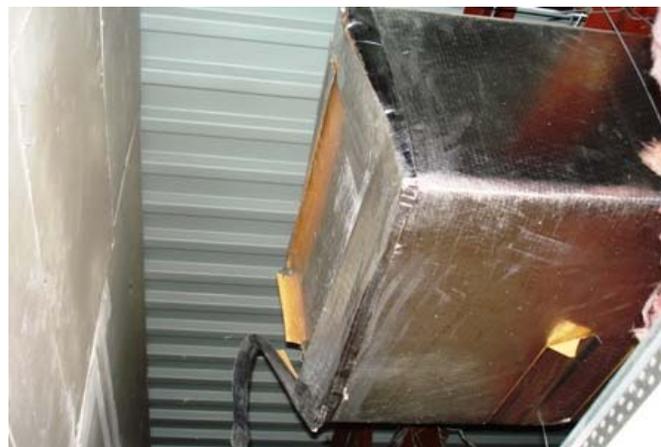
Figure 44 - Fiberglass Board Ductwork

The ductwork inside the building is mostly fiberglass ductwork. This ductwork is obsolete, considered unhealthy and should be removed and replaced with metal ductwork.

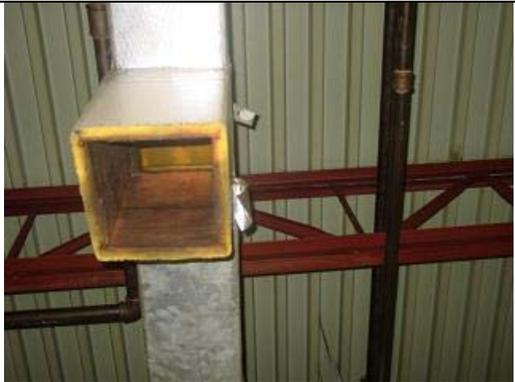
4532

Fiberglass ductwork is dirty, unhealthy and should be replaced with metal.

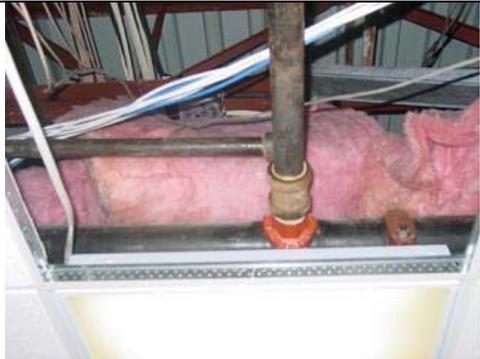
4536

Insulation appears to be on top of the suspended ceiling tiles. This type of installation is thermally ineffective and not healthy and should be replaced.
