**Town of Jaffrey, NH
Town Offices Comparative Site Study**

**Weller & Michal Architects Inc.
July 30, 2010**

re: Jaffrey Phase I Property Assessments

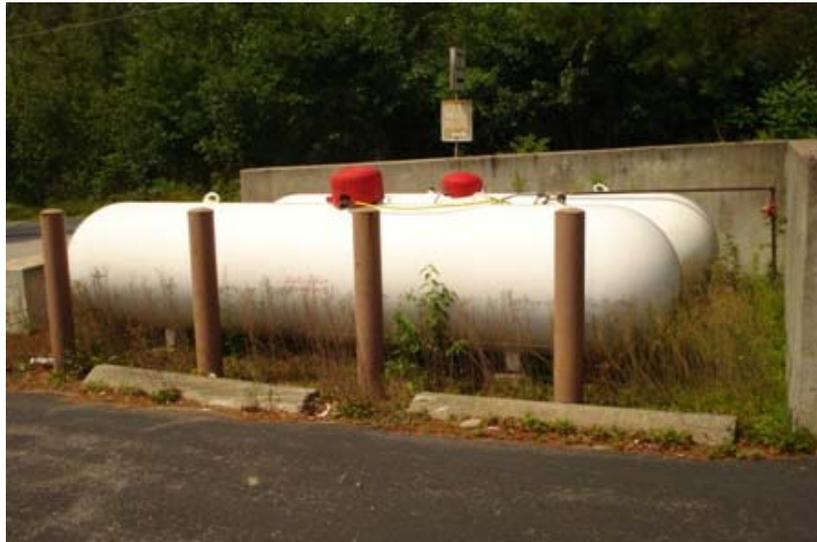
Figure 4 – Propane Storage Tanks

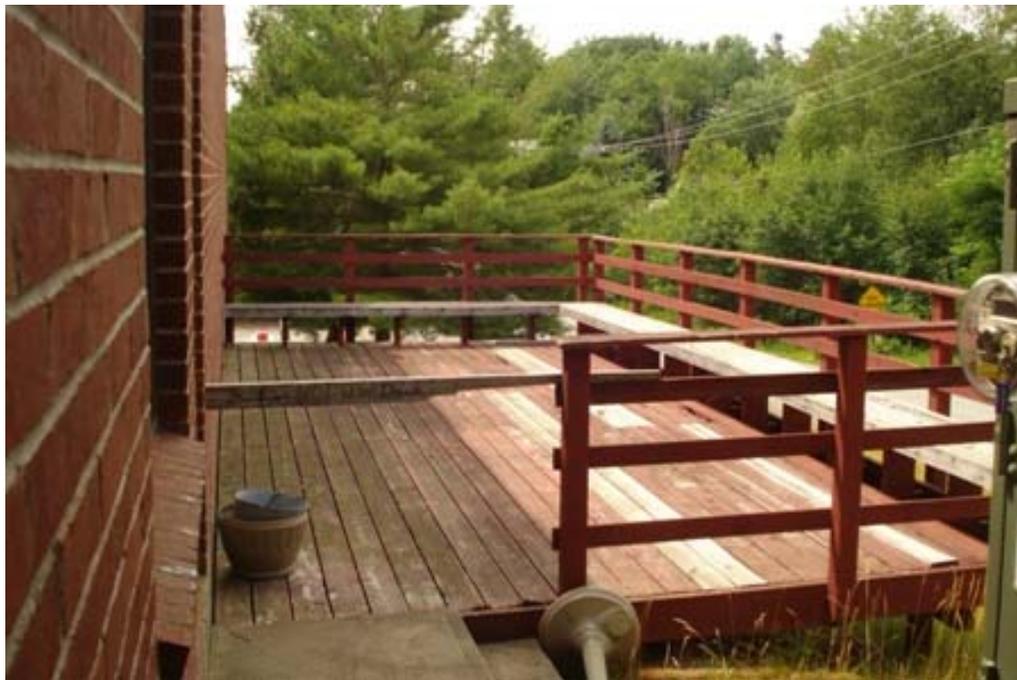
Landscaping around the building to the east is limited, and on the north and south is mature and plentiful. A repairable wood deck on the north provides an employee amenity adjacent to an existing breakroom.

Figure 6 – Wood Deck at North

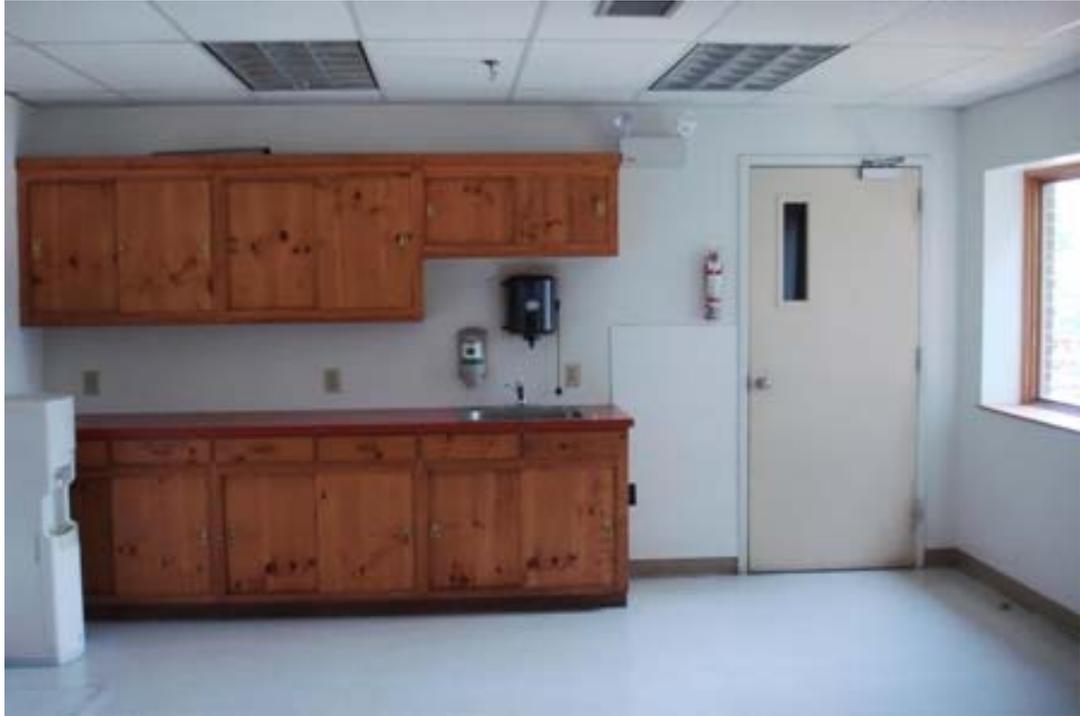
Original finishes were low to mid-range in quality, and show excessive wear and damage.

Figure 14 Interior Finishes at Existing Breakroom

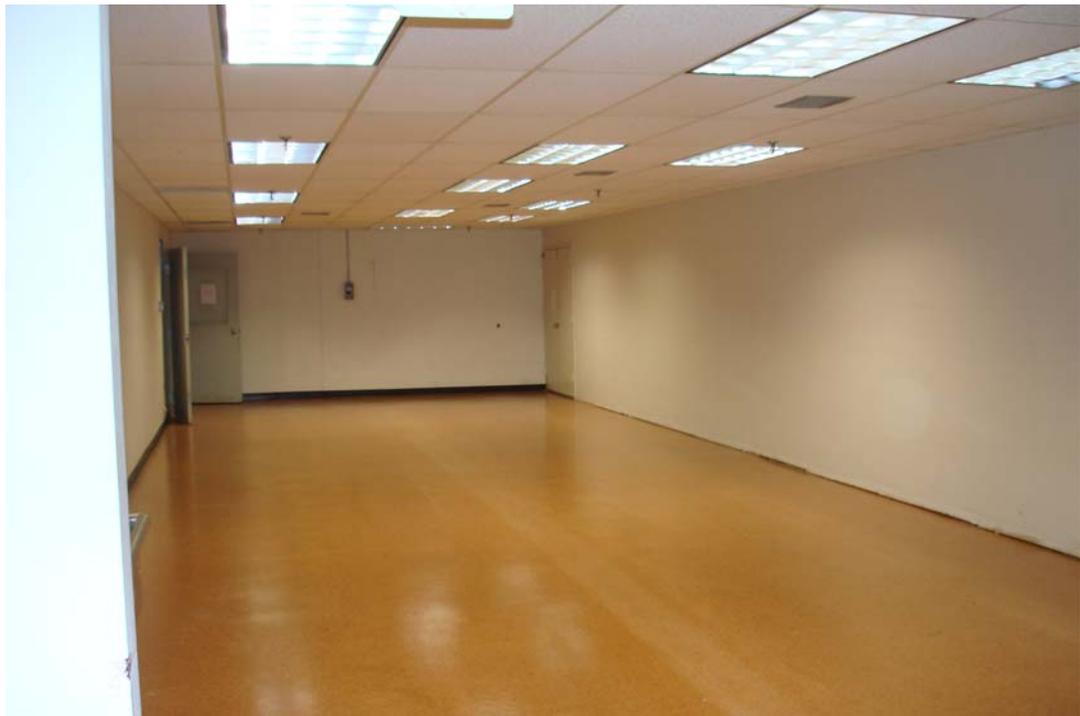
Figure 15 - Interior Finishes at Work Rooms

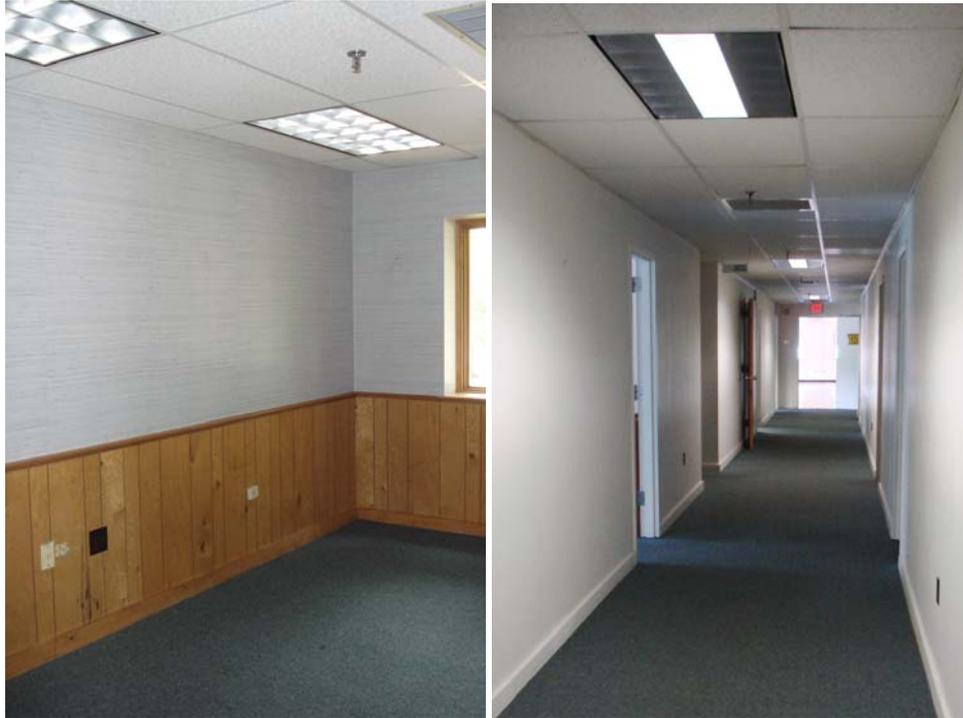
Figure 16 - Interior Finishes at Offices and Corridors

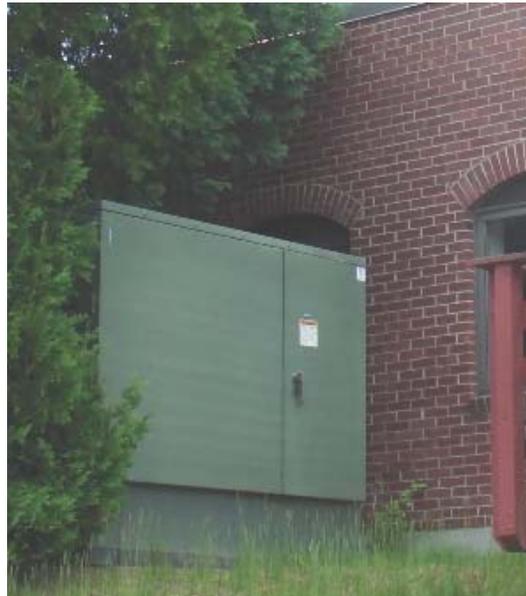
Figure 20 - Pad Mounted Transformer

The existing 800 amps three phase 4 wire 277/480 volts electrical service is more than adequate for the proposed building uses. The pad mounted transformer on the north side is closer to existing windows than currently allowed by utilities, however need not be replaced.

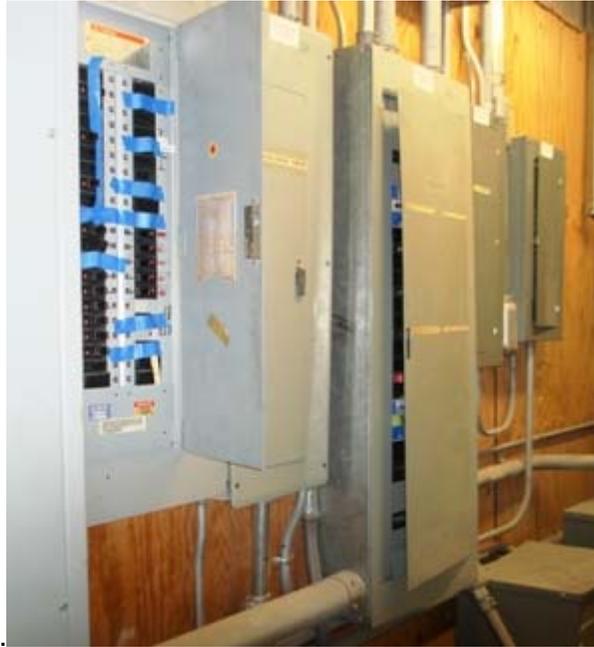
Figure 21 - Electrical Service

Distribution panels are original equipment or date from numerous tenant modifications. They are considered to be in poor condition and should be replaced.

The existing electrical distribution system shows extensive tenant modification that is not code compliant and should be replaced. New distribution to new lighting and power panels located as needed for the new uses is recommended. This need only be done for the upper level as the lower level should be redesigned around specific uses yet to be identified.

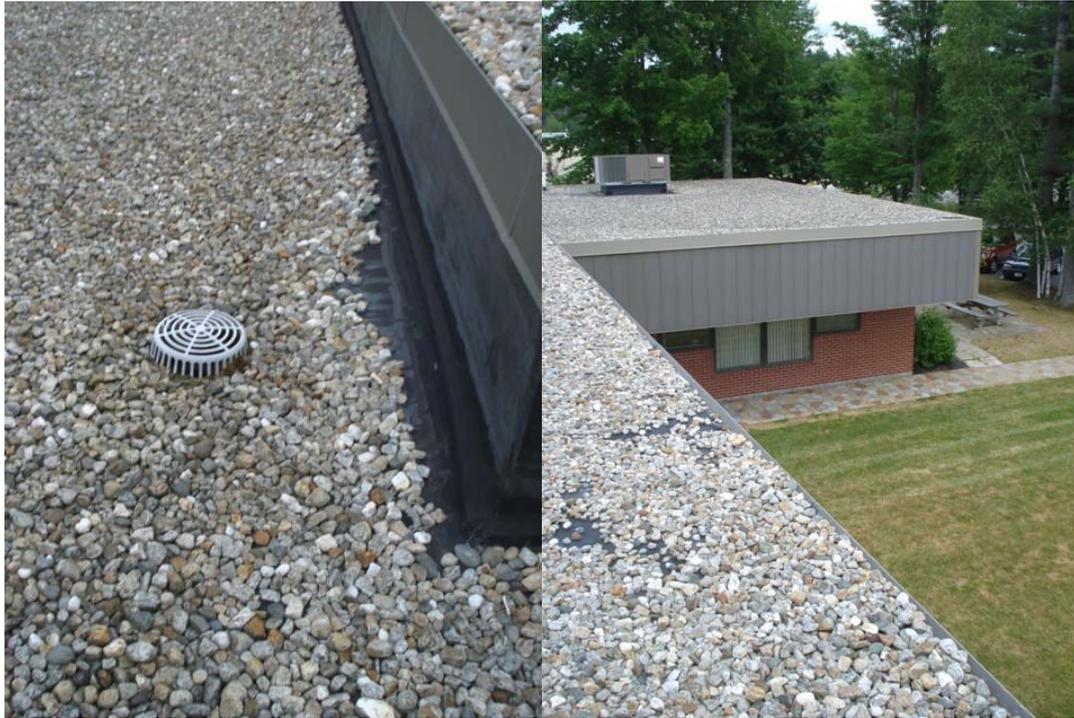
Roofs were last inspected in 2008.¹ Roofs are low-slope (flat) roofs with 2 inches of rigid insulation above a steel deck covered with stone-ballasted EPDM rubber membranes. Roofs are drained to interior storm drains which are missing protective baskets. Roofs are in good condition but are likely near the end of their useful life.

Figure 30 - Ballasted EPDM Roofing

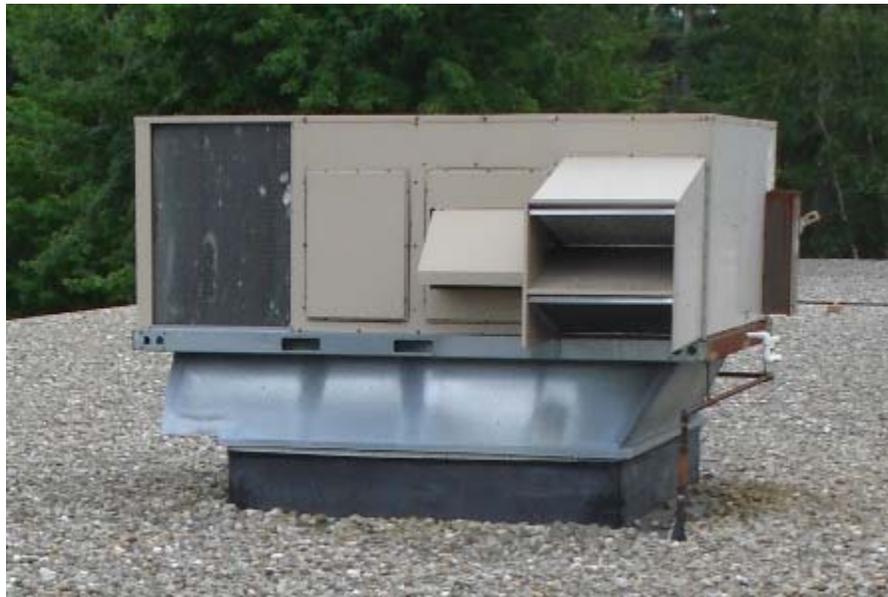
Figure 31 - HVAC Roof Top Units

Because the rooftop units are old and use a phase-out, environmental unfriendly refrigerant, and because zoning and ductwork changes would be needed to accommodate necessary plan changes for Town Offices, we recommend a complete replacement of the older rooftop units.

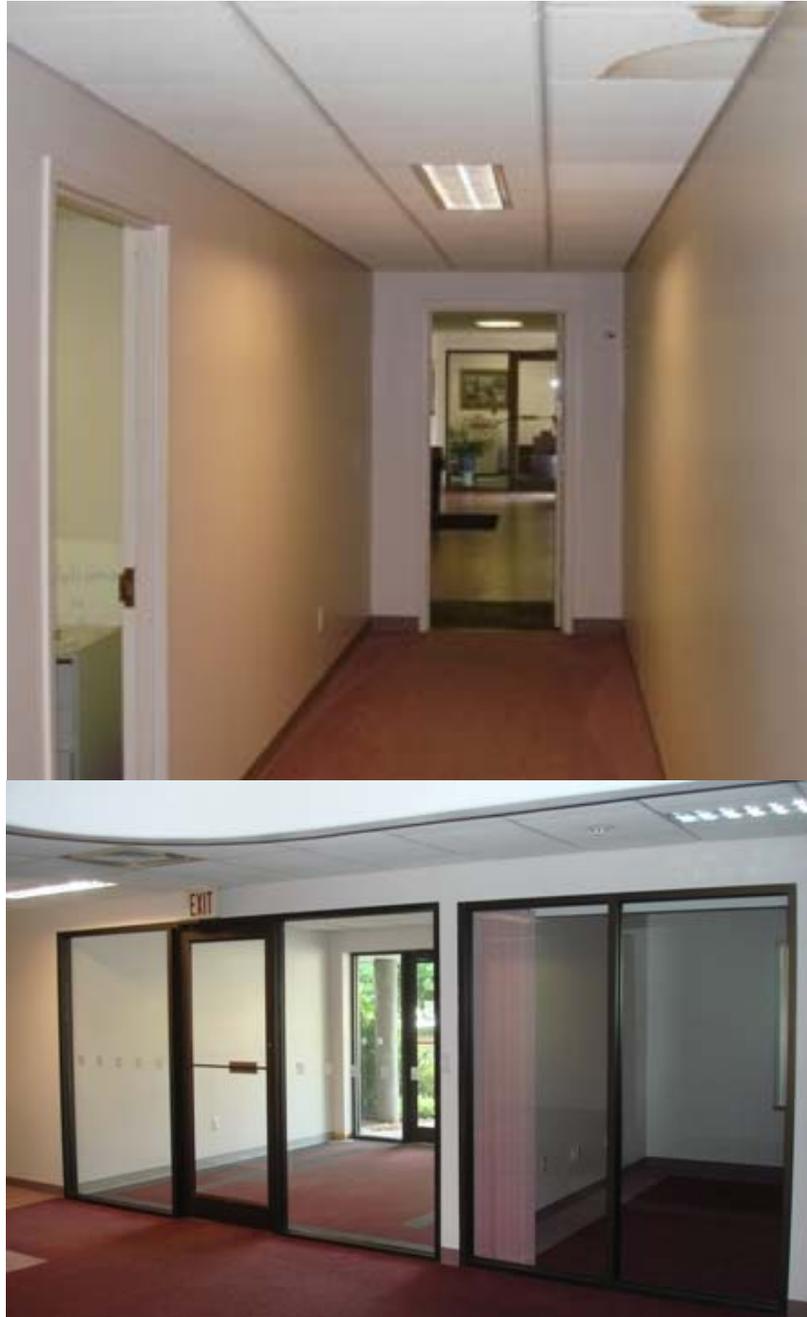
The interior of the Somero building is in very good shape. Original finishes were above average in quality and with few exceptions (such as water damage to ceiling tiles) they show little evidence of excessive wear or damage.

Figure 38 - Interior Partitions

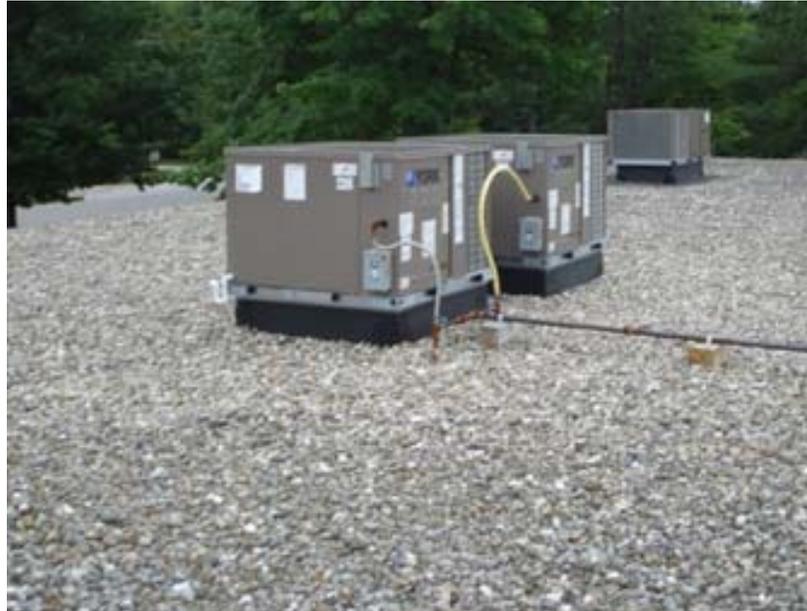
the front office section with a total capacity of about six tons were recently installed to allow for current leases to multiple tenants. With the exception of the newer York units the zoning is limited.

Figure 43 - New Roof Top Units

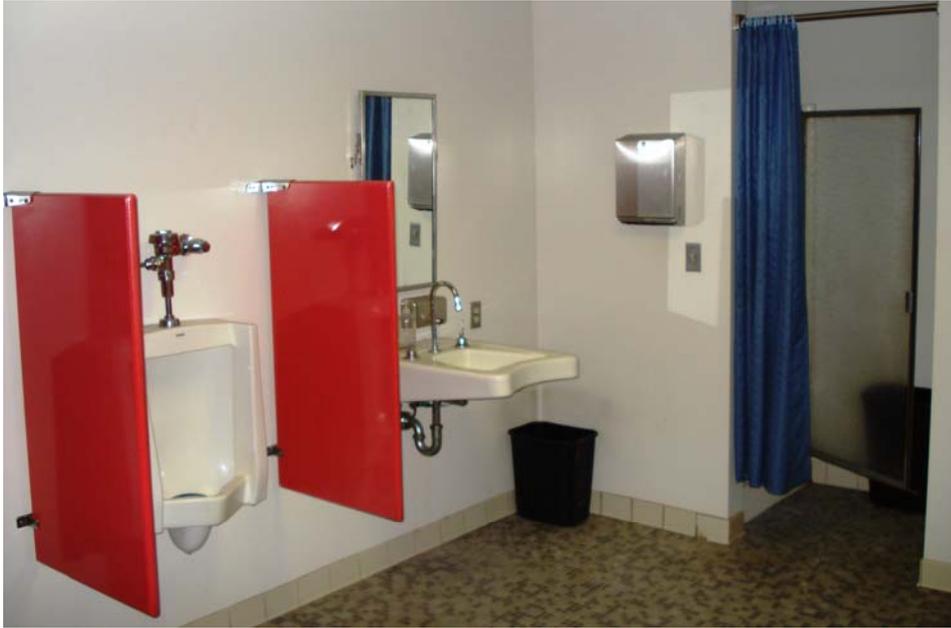
Existing toilets are in good condition with ceramic tile floors. Fixture count is adequate or even in excess of likely need. The toilet rooms for both office and warehouse areas occupy about 8% of floor area. However, it is not likely to be economically justifiable to relocate or significantly remodel these toilet rooms.

Figure 45 - Existing Toilet Rooms

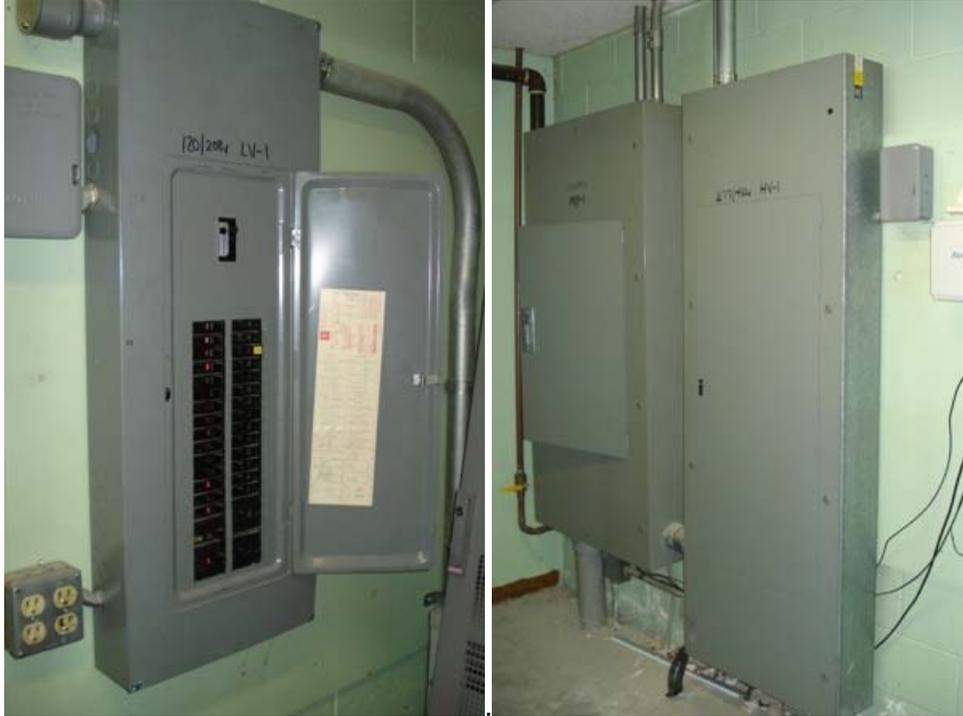
Figure 47 - Electrical Service

Main panel boards in the electric room and step-down transformers appear to be in good condition. The existing electrical distribution system needs modifications only as needed to accommodate any proposed renovations.

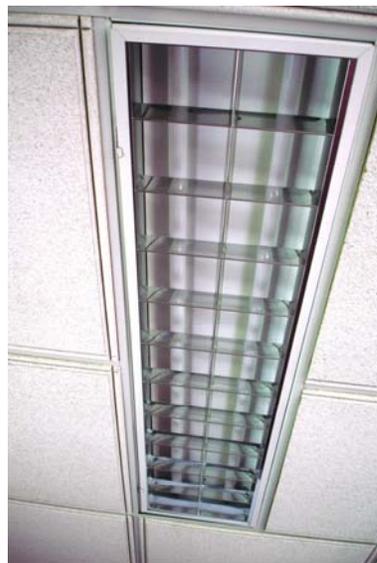
Figure 48 - Parabolic Troffer Lighting

Lighting in areas already used as offices have been recently upgraded to fixtures with T8 lamps and electronic ballasts. Major modifications are only needed to accommodate any proposed renovations.

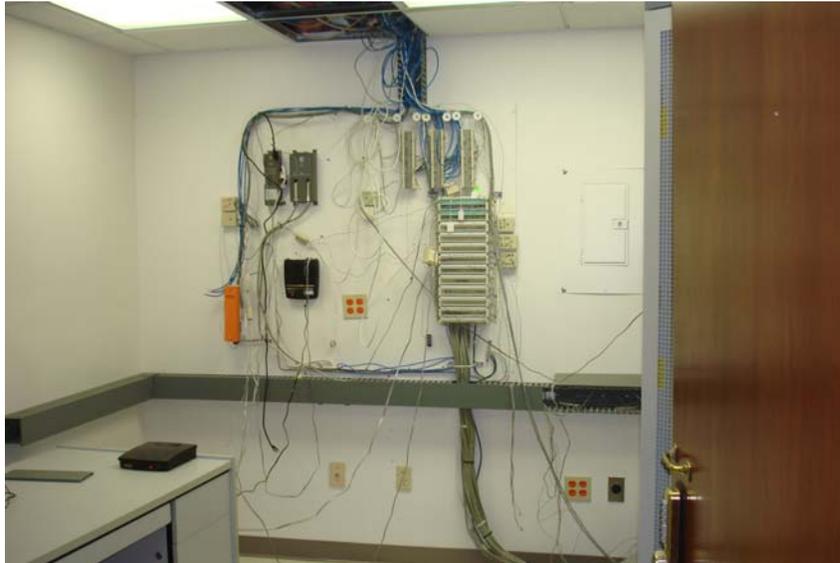
An existing Telecomm room is served by raceways and a split-system HVAC unit dedicated to cooling computer and data rooms. This equipment is assumed to be in good condition; however, it is unlikely that the room layout and location will suit a newly reconfigured floor plan around the Town Office program.

Figure 49 - Existing Telecommunications Room

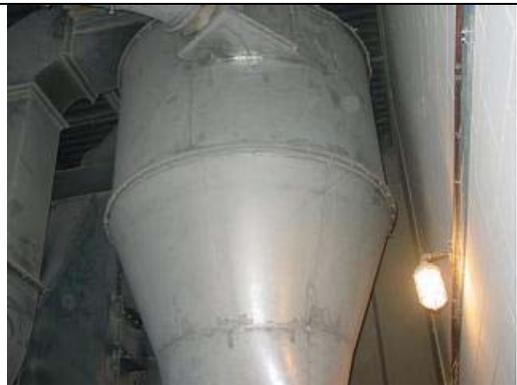
4508

A bag house is part of the system.

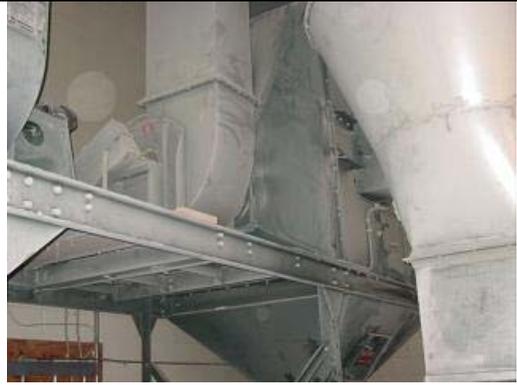
4509

As is extensive ductwork system for dust collection.

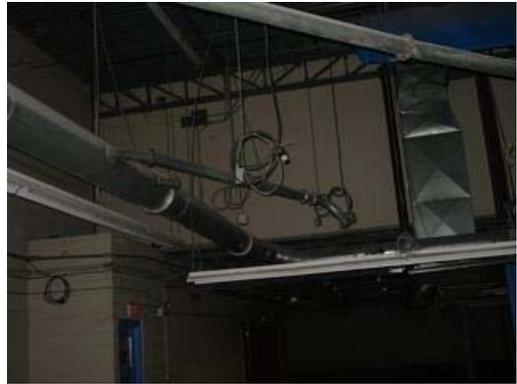
4511

<p>More ductwork for dust collection that could also be adapted for other exhaust.</p>

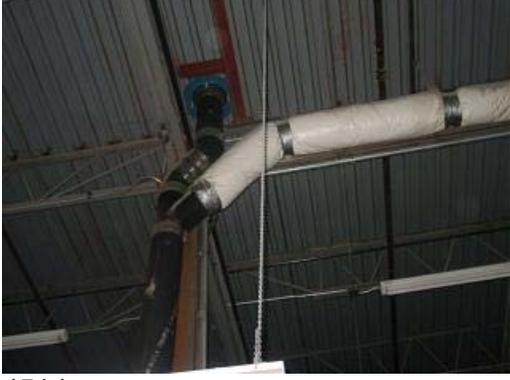
<p>4514</p>
<p>Air supply duct to downstairs space.</p>

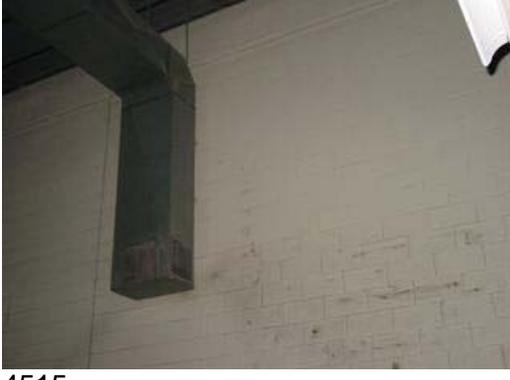
<p>4515</p>
<p>Additional air supply duct to the downstairs space.</p>

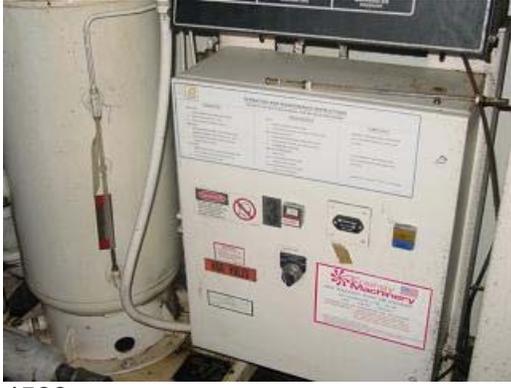
<p>4522</p>
<p>And filter dryer system.</p>

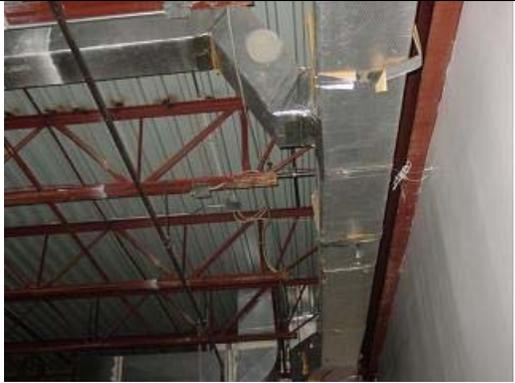
4526

The ductwork inside the building is mostly fiberglass ductwork. Zoning is rather limited, so several offices share one thermostat. It was also observed that the ceiling insulation consists of fiberglass batts on top of the suspended ceiling tiles.

Fiber glass ductwork in shipping and receiving area. This is typical of ductwork in the building.

Fiberglass ductwork is dirty, unhealthy and should be replaced with metal.

Options and Recommendations. These systems are similar to the system at the Printegra building and the same options and recommendations apply, with the following exceptions. The fiberglass ductwork is unhealthy and should be removed and replaced with metal ductwork.
